CLIENT:  
Vienna Woods  
2 Roxburgh Street  
Newmarket  
Auckland 1023

SAMPLE DESCRIPTION:  
Petit Chateau with lacquer finish planks assembly with  
Selleys PVA adhesive applied in the joints.

## RESILIENT FLOOR COVERINGS (BASED ON ISO 4760:2022(E) - LAMINATE FLOORING – TOPICAL MOISTURE RESISTANCE – ASSEMBLED JOINT (MODIFIED))

**No. 1542720.6**

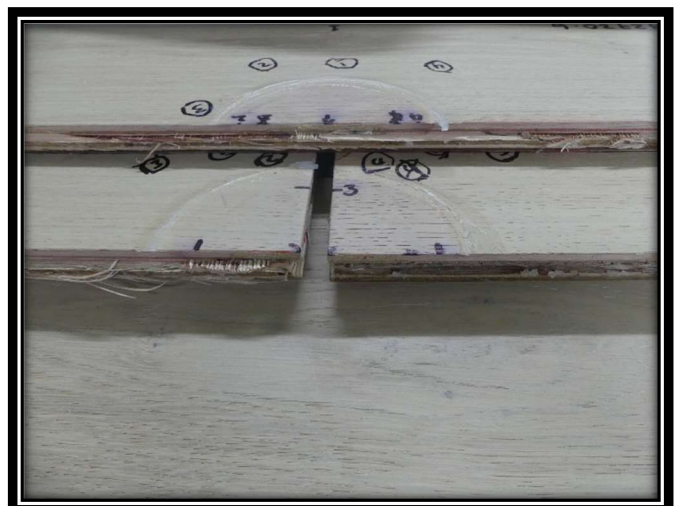
Recovered Swell (Disassembled)

Disassembly Observations:	Specimen 1	Specimen 2	Specimen 3
Migration of water along the upper surface:	Yes	Yes	Yes
Migration of water to the underside:	No	No	No
