# No. 1435555.6

SAMPLE DESCRIPTION:  
 Flooring planks:  
 Coating – Lacquer  
 Connection System – T & G

## ISO 4760:2022(E) - LAMINATE FLOORING – TOPICAL MOISTURE RESISTANCE – ASSEMBLED JOINT (MODIFIED)

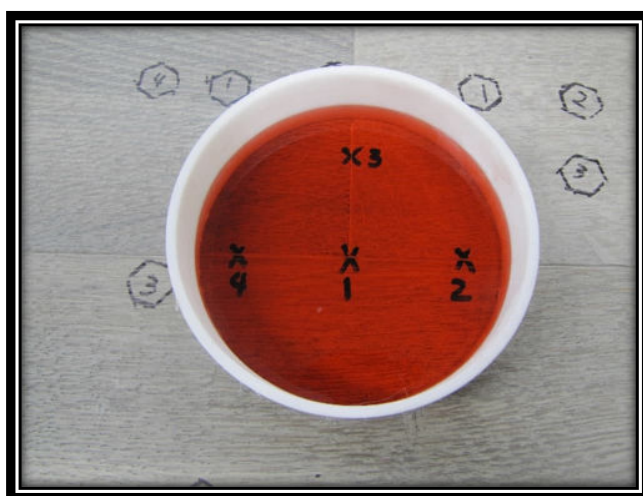
24 hrs With Water

| | Wet Swell | | |
|---|---|---|---|
| Observations: | The water was able to channel through the joints and puddle on the surface of the planks. However, No water penetration through the joints. There was water left inside the ring after 24 hrs. | No water penetration through the joints. | No water penetration through the joints. |

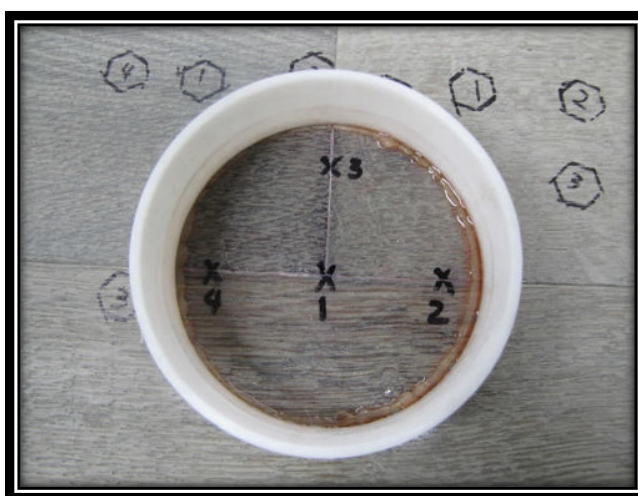
Wet Swell

| Quantitative Results: | Wet Swell (mm) | | | Recovered Swell (mm) | | |
|---|---|---|---|---|---|---|
| Final Average (Positions 2 to 4) | 0.27 | 0.18 | 0.13 | 0.21 | 0.10 | 0.02 |

| | Wet Swell | | | Recovered Swell | | |
|---|---|---|---|---|---|---|
| Qualitative Ratings (individual results): | 1 | 1 | 1 | 1 | 1 | 1 |

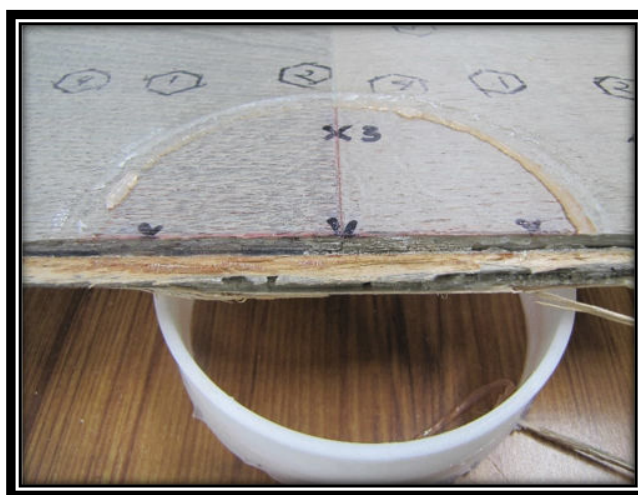
Recovered Swell (Disassembled)

| | Recovered Swell | | |
|---|---|---|---|
| Disassembly Observations: | No evidence of water penetrating the joints. Water remained on the surface of the joints. | No evidence of water penetrating the joints. Water remained on the surface of the joints. | No evidence of water penetrating the joints. Water remained on the surface of the joints. |

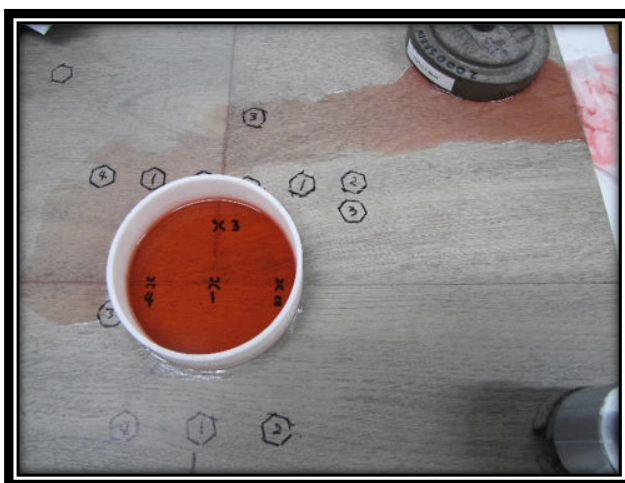
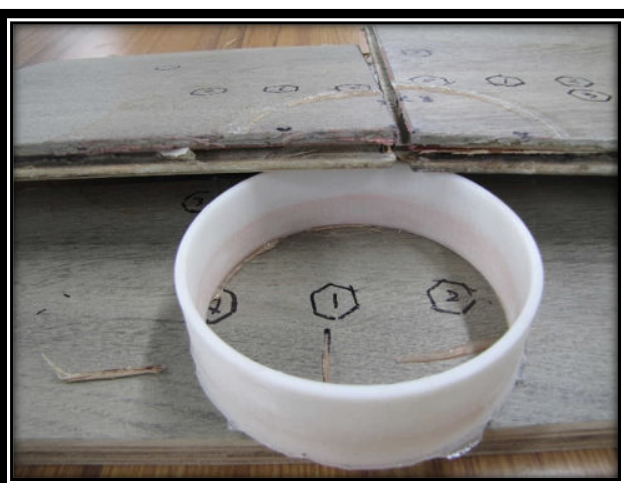
**Sample 1 - Water was able to channel through the joints and puddle on the surface of the planks.**
