# E3 Alternative Solution Icons

Substantiation for specifying Icons engineered oak flooring in rooms containing sanitary fixtures and sanitary appliances, as an Alternative Solution to E3/AS1.

| DOCUMENT | VW-E3-IC-001 · version 3.0 |

**New Zealand Wool Testing Authority Ltd**  
**Report 1542720.6**

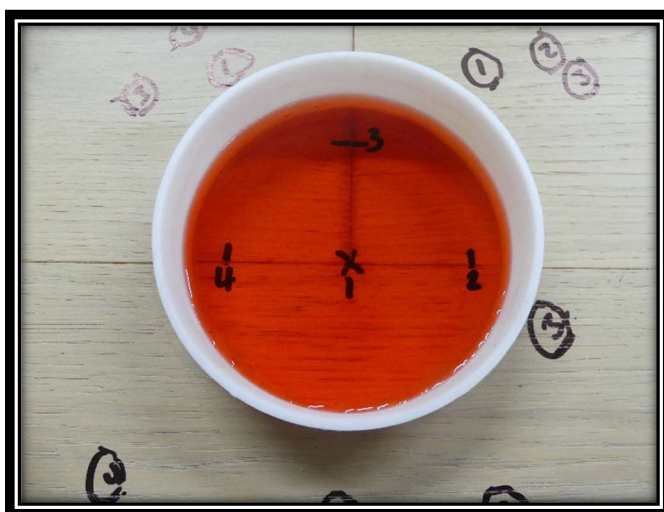
After 24 hrs With Water

100 mls of dye solution was applied onto the sample surface. It was poured into a cylinder 100mm diameter placed in the centre of the sample at the "T joint." Sealant was used at the plank/cylinder interface to avoid leakage.

The sample was placed on white paper towels prior to testing to enable detection of any dye penetration through the joints.

The sample was left at 20°C, 65% Relative Humidity room conditions for 24 hours after the dye was added and then examined for dye penetration through the backing (not 23°C, 50% RH as stated in the method).

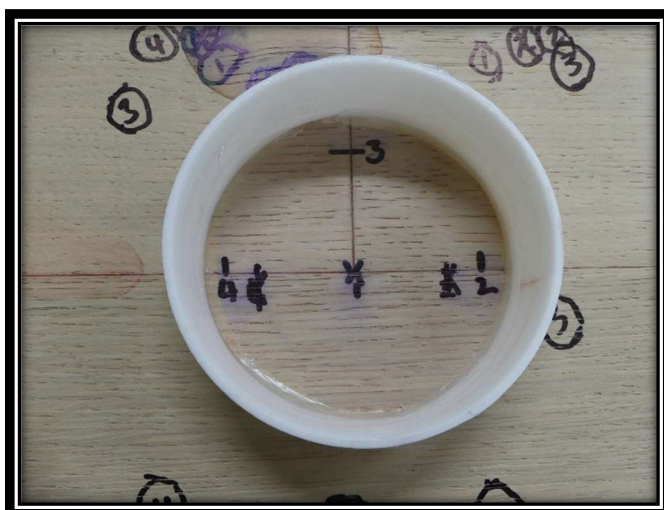
Recovered Swell

Quantitative measurements are used to calculate surface swell in mm (within 15 minutes after water removal) and recovery swell (24 hours after removal of water).

| Quantitative Results: | Wet Swell (mm) | | | Recovered Swell (mm) | | |
|---|---|---|---|---|---|---|
| Final Average Results<br>(Positions 2 to 4) | 0.30 | 0.44 | 0.22 | 0.26 | 0.21 | 0.08 |

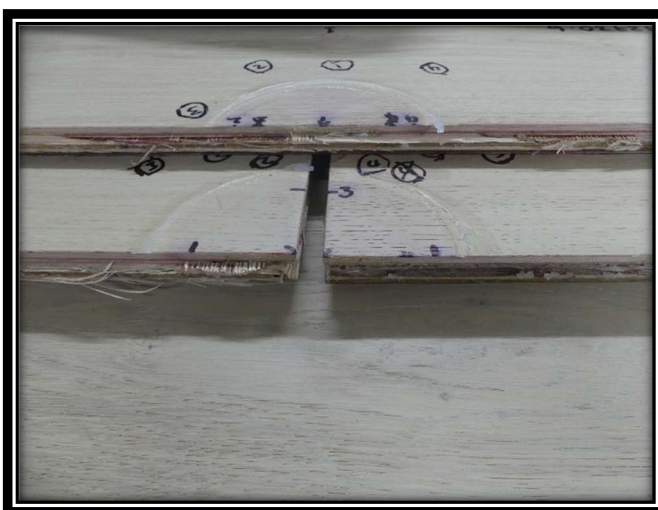
Recovered Swell (Disassembled)

| Disassembly Observations: | Specimen 1 | Specimen 2 | Specimen 3 |
|---|---|---|---|
| Migration of water along the upper surface: | Yes | Yes | Yes |
| Migration of water to the underside: | No | No | No |
