# E3 Alternative Solution Icons

Substantiation for specifying Icons engineered oak flooring in rooms containing sanitary fixtures and sanitary appliances, as an Alternative Solution to E3/AS1.

| DOCUMENT | VW-E3-IC-001 · version 3.1 |

**New Zealand Wool Testing Authority Ltd**  
**Report 1542720.6**

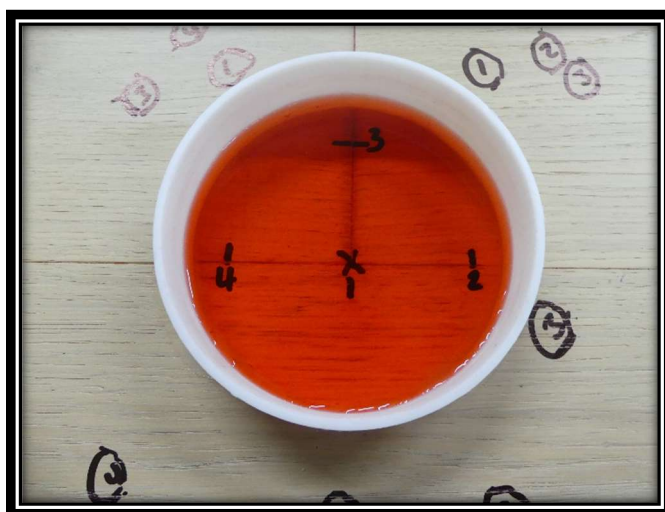
After 24 hrs With Water

100 mls of dye solution was applied onto the sample surface. It was poured into a cylinder 100mm diameter placed in the centre of the sample at the "T joint." Sealant was used at the plank/cylinder interface to avoid leakage.

The sample was placed on white paper towels prior to testing to enable detection of any dye penetration through the joints.

The sample was left at 20°C, 65% Relative Humidity room conditions for 24 hours after the dye was added and then examined for dye penetration through the backing (not 23°C, 50% RH as stated in the method).

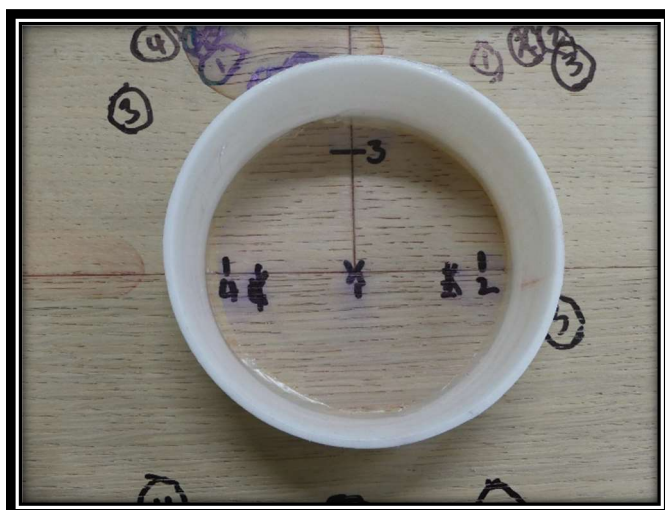
Recovered Swell

Quantitative measurements are used to calculate surface swell in mm (within 15 minutes after water removal) and recovery swell (24 hours after removal of water).

| Quantitative Results: | Wet Swell (mm) | | | Recovered Swell (mm) | | |
|---|---|---|---|---|---|---|
| Final Average Results<br>(Positions 2 to 4) | 0.30 | 0.44 | 0.22 | 0.26 | 0.21 | 0.08 |
| Final Results (Position 1) | 0.21 | 0.33 | 0.23 | 0.14 | 0.29 | 0.04 |
