# E3 Alternative Solution Petit Château

Substantiation for specifying Petit Château engineered oak flooring in rooms containing sanitary fixtures and sanitary appliances, as an Alternative Solution to E3/AS1.

| DOCUMENT | VW-E3-PC-001 · version 3.1 |

**New Zealand Wool Testing Authority Ltd**  
**Report 1542720.6**

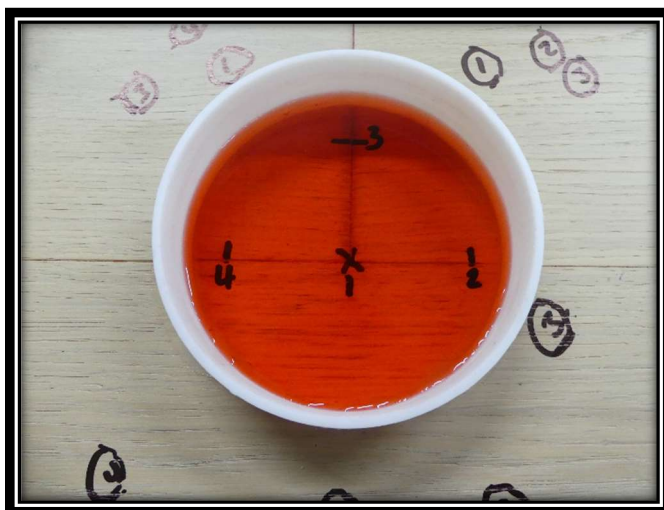
After 24 hrs With Water

100 mls of dye solution was applied onto the sample surface. It was poured into a cylinder 100mm diameter placed in the centre of the sample at the "T joint." Sealant was used at the plank/cylinder interface to avoid leakage.

The sample was left at 20°C, 65% Relative Humidity room conditions for 24 hours after the dye was added and then examined for dye penetration through the backing (not 23°C, 50% RH as stated in the method).

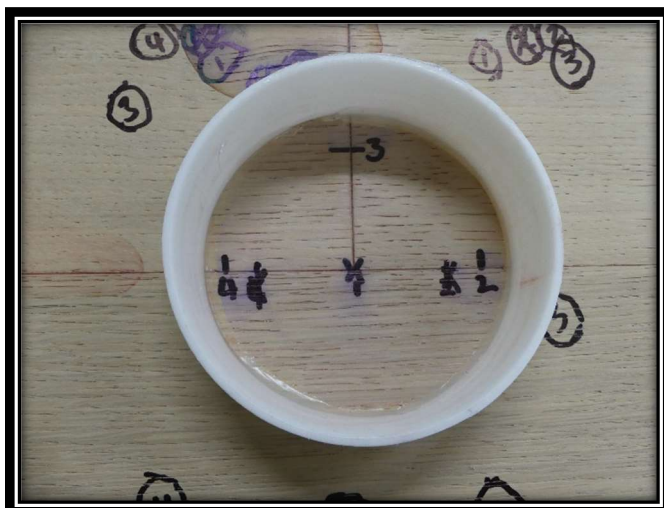
Recovered Swell

Quantitative measurements are used to calculate surface swell in mm (within 15 minutes after water removal) and recovery swell (24 hours after removal of water).

| Quantitative Results: | Wet Swell (mm) | | | Recovered Swell (mm) | | |
|---|---|---|---|---|---|---|
| Final Average Results<br>(Positions 2 to 4) | 0.30 | 0.44 | 0.22 | 0.26 | 0.21 | 0.08 |
| Final Results (Position 1) | 0.21 | 0.33 | 0.23 | 0.14 | 0.29 | 0.04 |
