# E3 Alternative Solution Patina Collection

Substantiation for specifying Patina Collection engineered oak flooring in rooms containing sanitary fixtures and sanitary appliances, as an Alternative Solution to E3/AS1.

| DOCUMENT | VW-E3-PT-001 · version 3.1 |

**New Zealand Wool Testing Authority Ltd**  
**Report 1435555.6**

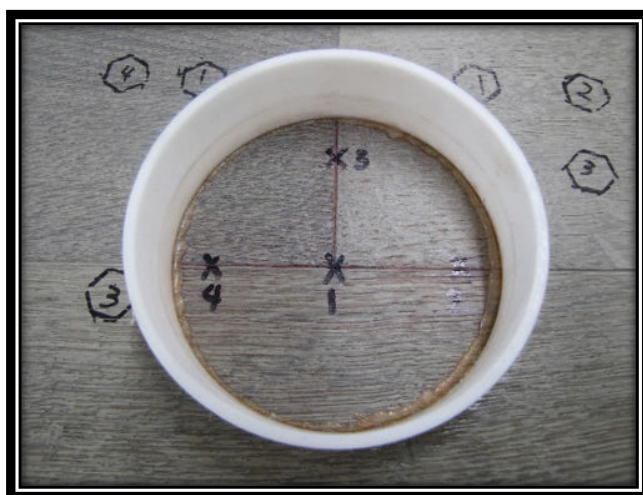
Recovered Swell

| Quantitative Results: | Wet Swell (mm) | | | Recovered Swell (mm) | | |
|---|---|---|---|---|---|---|
| Final Average (Positions 2 to 4) | 0.27 | 0.18 | 0.13 | 0.21 | 0.10 | 0.02 |
| Final average (Position 1) | 0.45 | 0.26 | 0.20 | 0.45 | 0.06 | 0.07 |

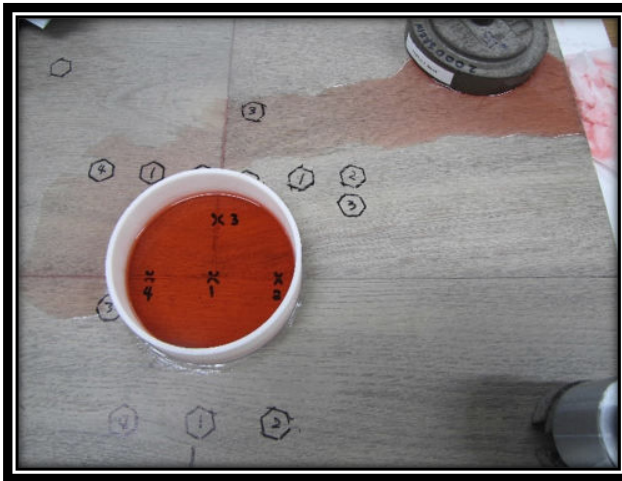
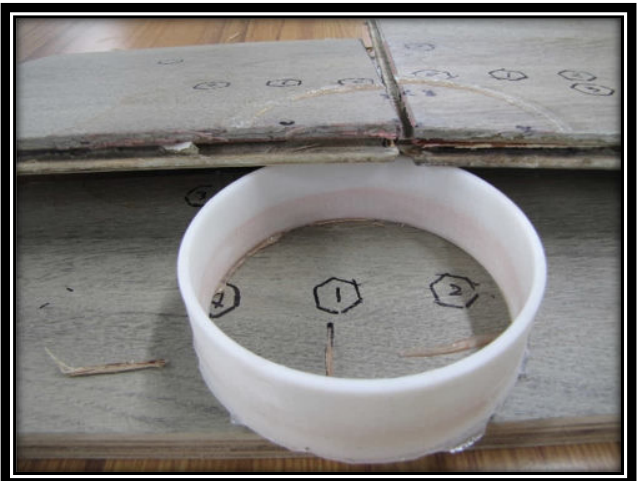
**Sample 1 - Water was able to channel through the joints and puddle on the surface of the planks.**

| Water penetration through the joints | None on any specimen. On specimen 1 the laboratory also recorded that the water was able to channel through the joints and puddle on the surface of the planks, and that water was left inside the ring after 24 hours. |

| | Wet Swell | | |
|---|---|---|---|
| Observations: | The water was able to channel through the joints and puddle on the surface of the planks.<br>However, No water penetration through the joints.<br>There was water left inside the ring after 24 hrs. | No water penetration through the joints. | No water penetration through the joints. |

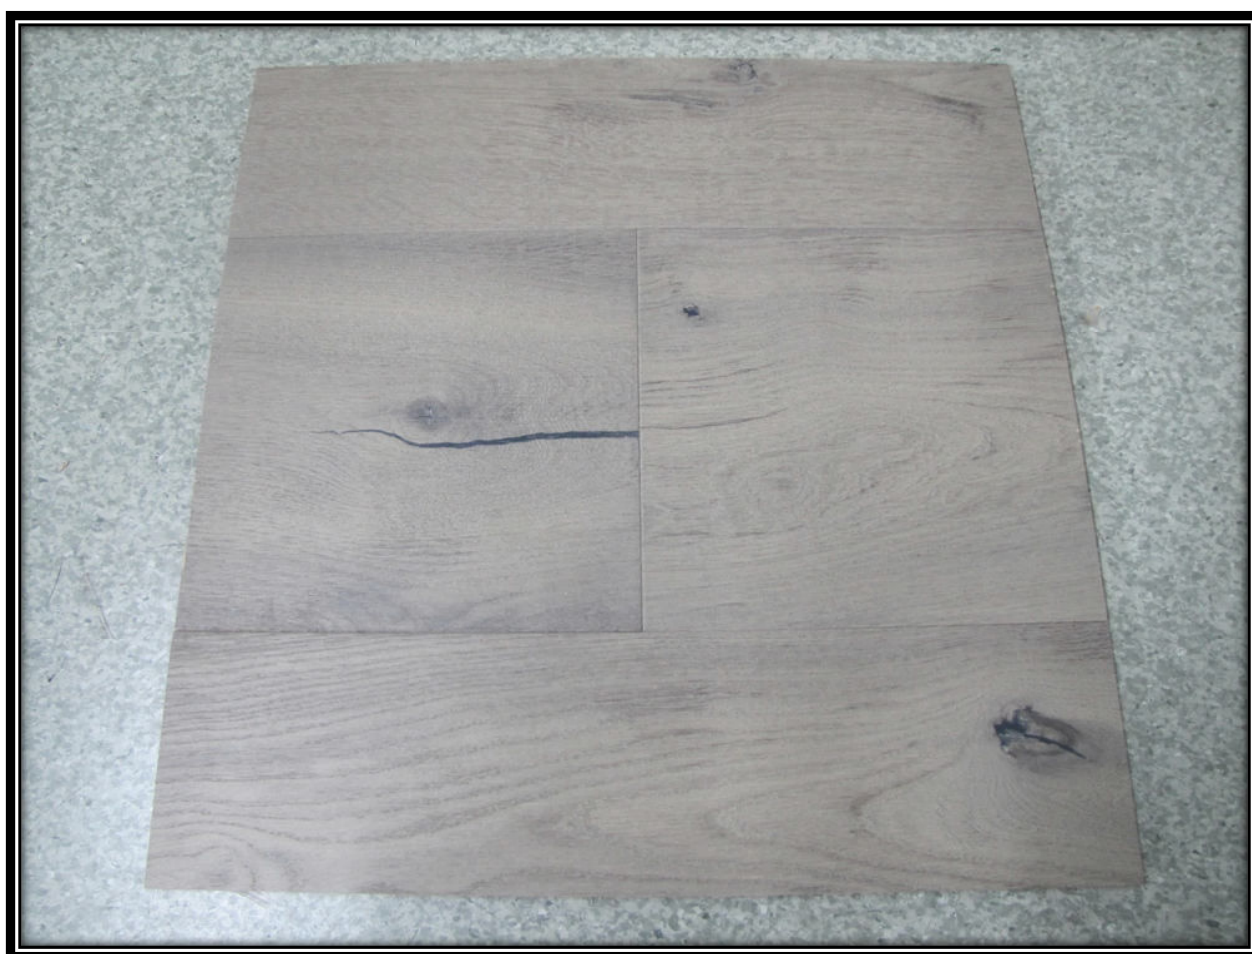
100 mls of dye solution was applied onto the sample surface. It was poured into a cylinder 100mm diameter placed in the centre of the sample at the "T joint." Sealant was used at the plank/cylinder interface to avoid leakage.

The sample was left at 20°C, 65% Relative Humidity room conditions for 24 hours after the dye was added and then examined for dye penetration through the backing (not 23°C, 50% RH as stated in the method).
